## FROM TRAFFIC BOTTLENECK TO TOURIST ATTRACTION: The Transformation of The Tha Phae Gate in Chiang Mai, Thailand

By Don Hubbard

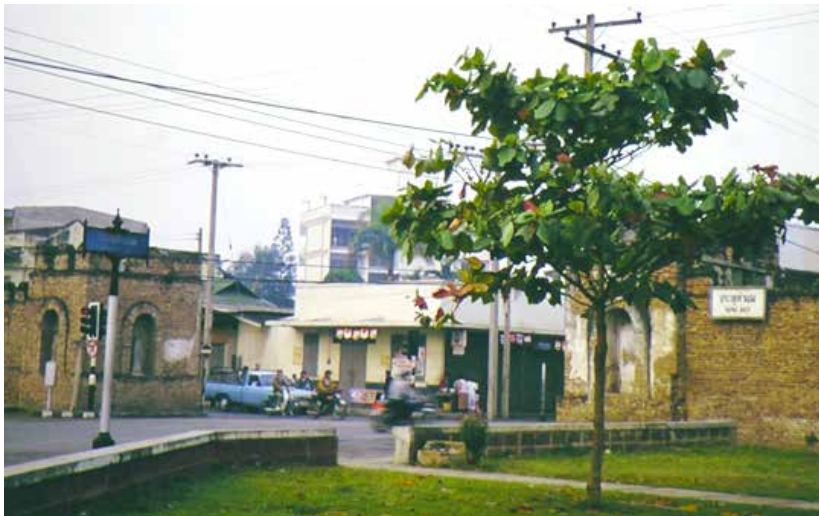
**Figure 3: Tha Phae Gate Prior to Project (JIRCAS, 1985)**

View from northeast looking southwest towards the inner city. Note how the wall limits the ability of westbound and northbound drivers to see each other. The photographer had to position himself about 20m to the side in order to bring northbound vehicles into view, as they are not visible from the westbound lanes.

Poor sight distance led to many right-angle collisions when drivers failed to heed the red light, as the motorcyclist is doing in the photo (note that the light is red). The motorcyclist is on the wrong side of the road, too. He is across the center line (Thais drive on the left side of the road) and on top of the painted traffic arrow pointing in the opposite direction. Also note that the sidewalks end at the wall rather than continuing through the gate. Pedestrians passing westbound through the gate did so in the travel lanes, and again were not visible to northbound drivers.

- The overall configuration for the city's road network tended to funnel traffic through the gate, due to the lack of alternate routes between many origin-destination pairs.
- There were sidewalks on most of the streets, but none within the gate itself (see Figure 3). Pedestrians were forced to walk in the travel lanes, with the possibility of being crushed against the wall by a passing vehicle.

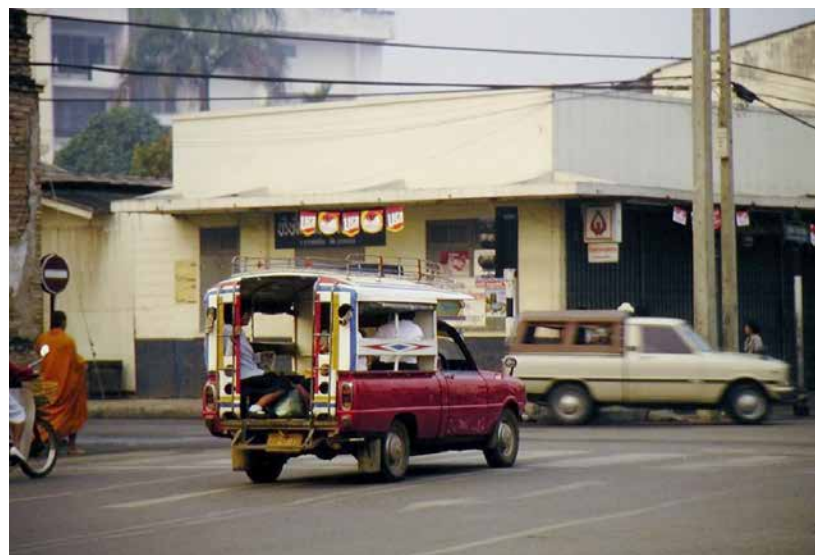
**Figure 4: Another View of the Pre-Project Condition (JIRCAS, 1985)**

View looking west through the gate. Note the monk at left walking in the street and about to reach the blind corner caused by the wall. He is looking straight forward rather than to the left, the direction vehicles would come from. Note also the northbound pickup running a red light into the path of the minibus in the center of the picture.

- There was no separation of traffic types, despite the great differences in size and speed. Besides pedestrians and cars, there were trucks, street vendors' pushcarts, informal buses (see Figure 4) picking up and discharging passengers, pedicabs, and many, many, motorcycles.

In the Tha Phae gate area, the worst accidents occurred where the west-bound traffic on Tha Phae Road crossed northbound traffic just inside the gate. Drivers in these two movements could not see each other because the brick wall, with no setback, blocked the view. The intersection was signalized, which should have resolved this conflict, but poor driver discipline and red light running led to frequent right-angle collisions (see Figure 4)<sup>4</sup>.
